Woodlake Crossing Physical Pond Survey and Bathymetry

September, 2009

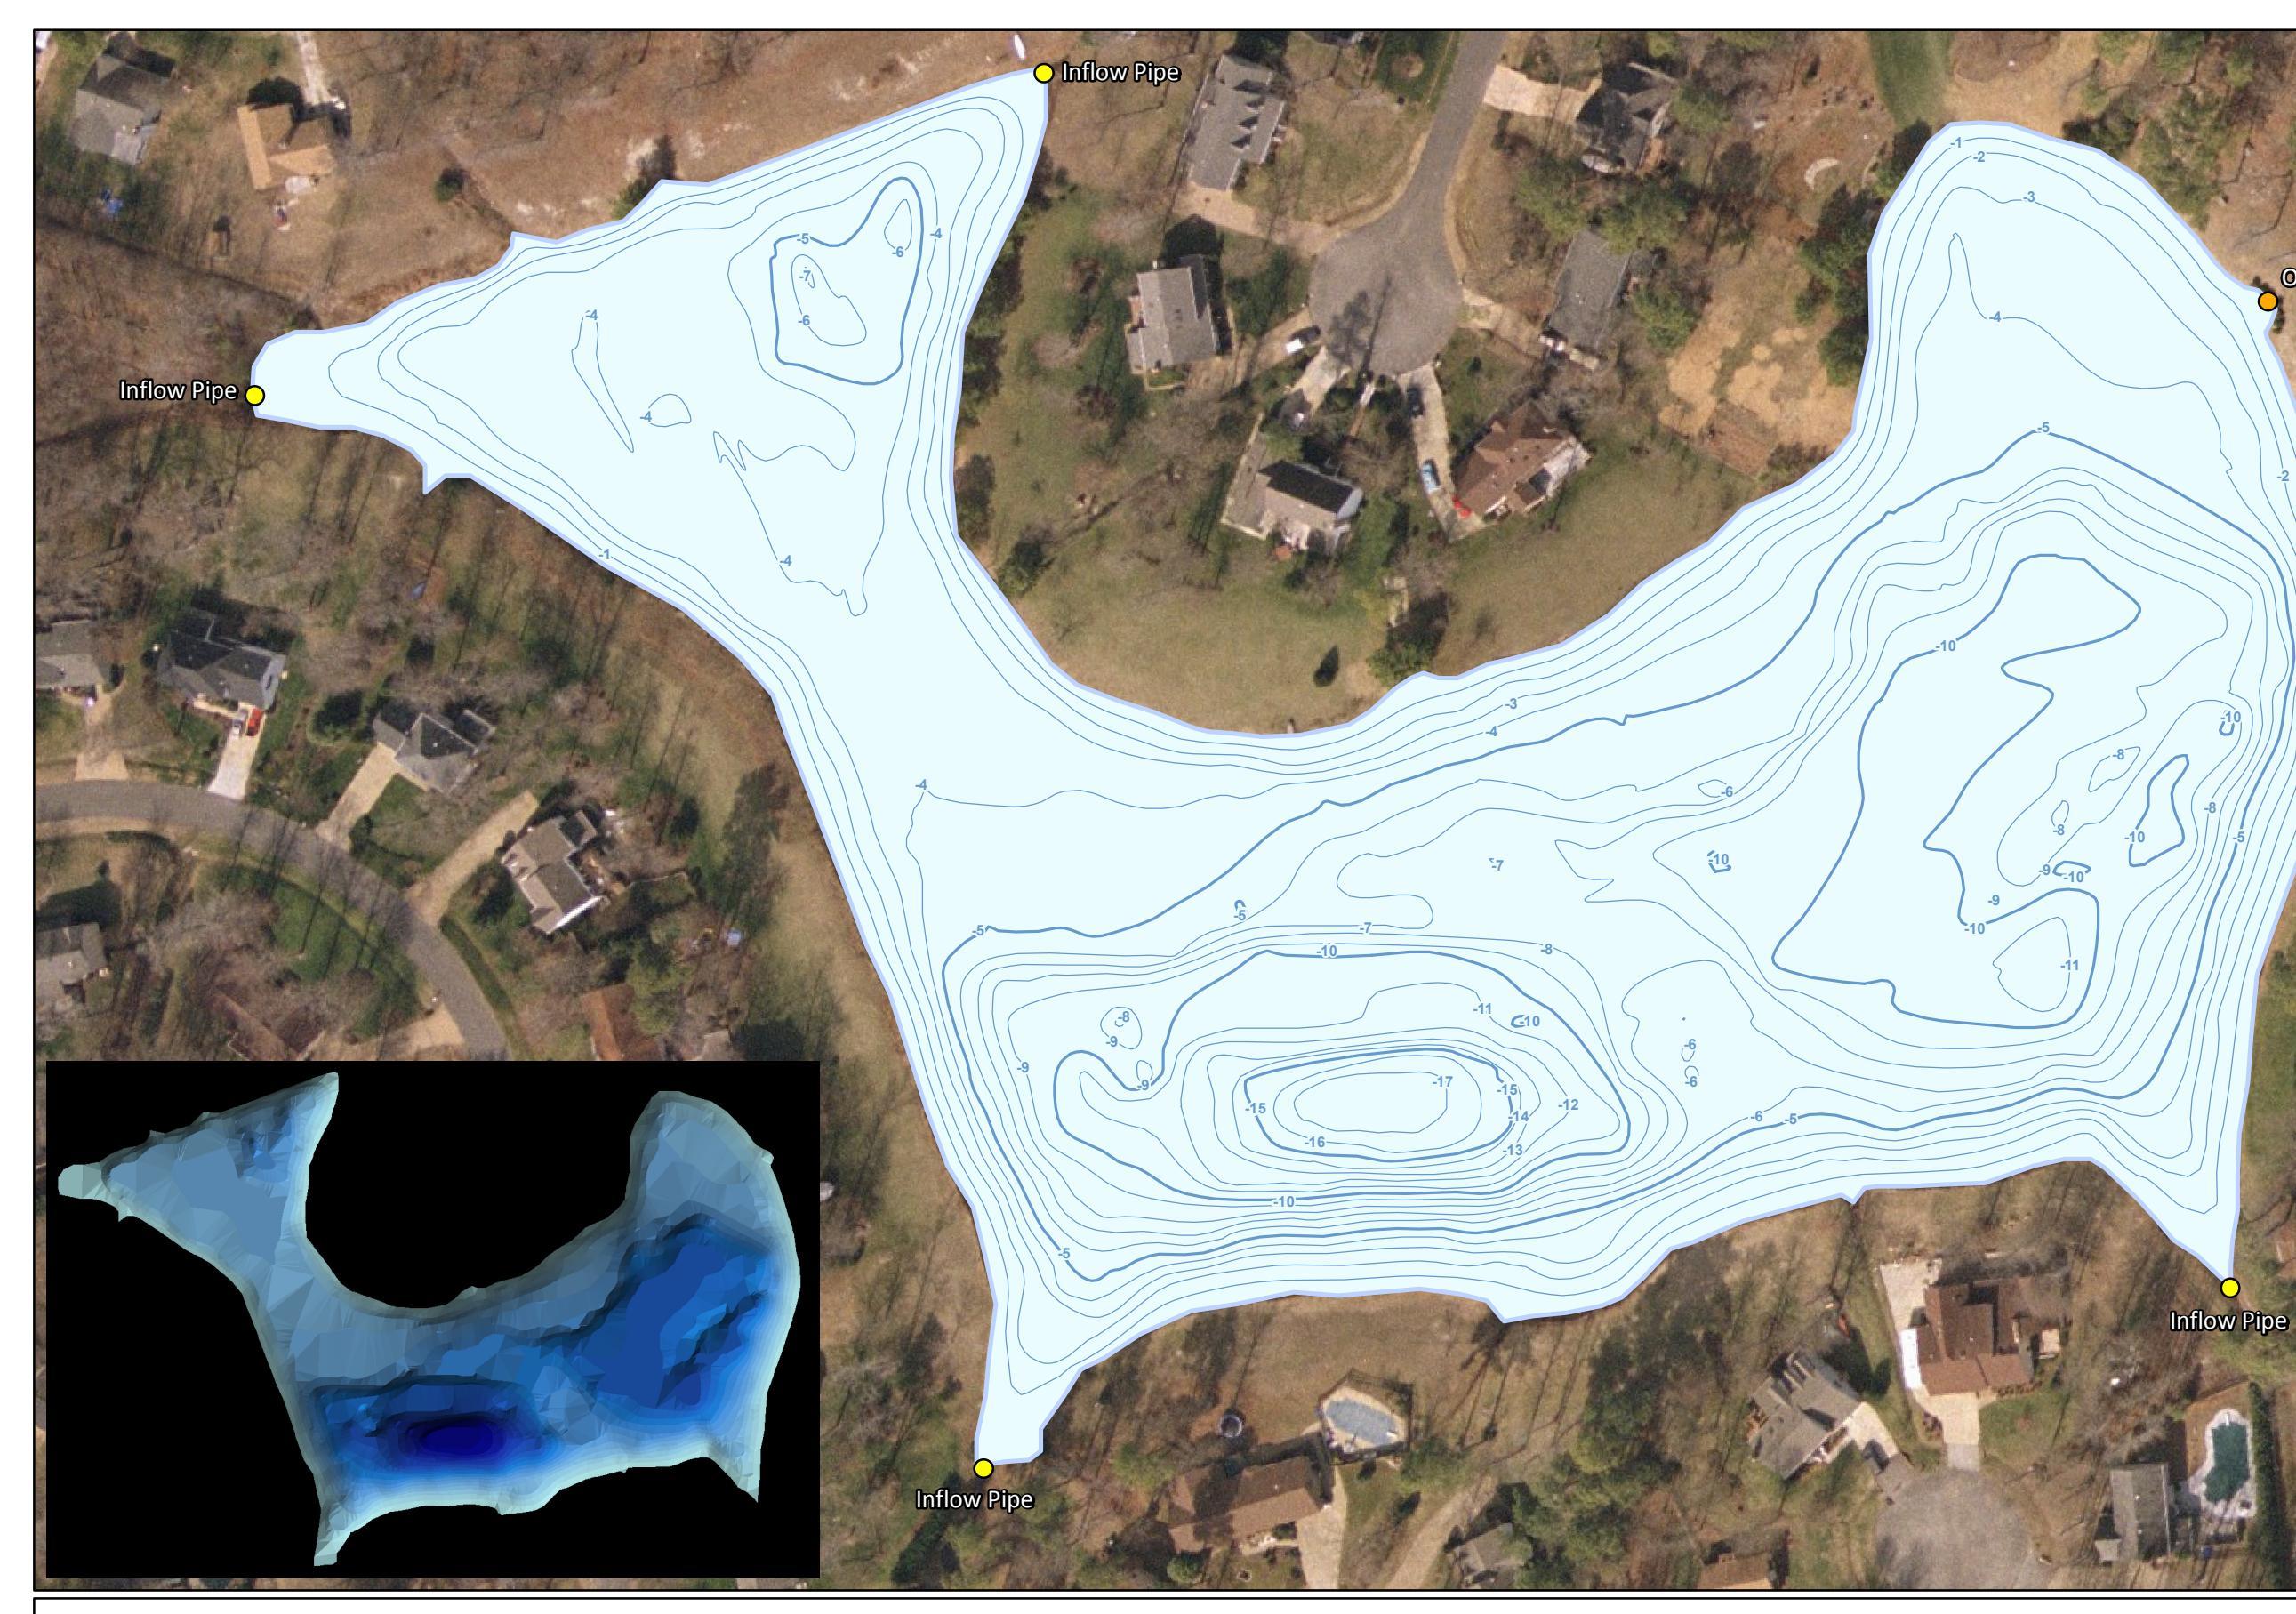
Woodlake Crossing - Contour

By integrating GPS and depth sounding equipment a bathymetric profile has been created for this pond. The pond measures an area of 10.5 Acres, has a max depth of 17.8 ft. and a mean depth of 5.4 ft which yields a volume of 59 acre feet or 19,250,000 gallons. Generally you would want an average depth of greater than 4 ft to maintain the healthy status of your pond. This pond is currently above the 4 ft average threshold. This pond has likely filled in some since it was originally constructed but without knowledge of the initial depth it is difficult to make a comparison with the current depths as determined by this bathymetric evaluation. With the information on initial conditions it would then be possible to compute a rate of sedimentation and be able calculate how long you have before dredging is necessary.

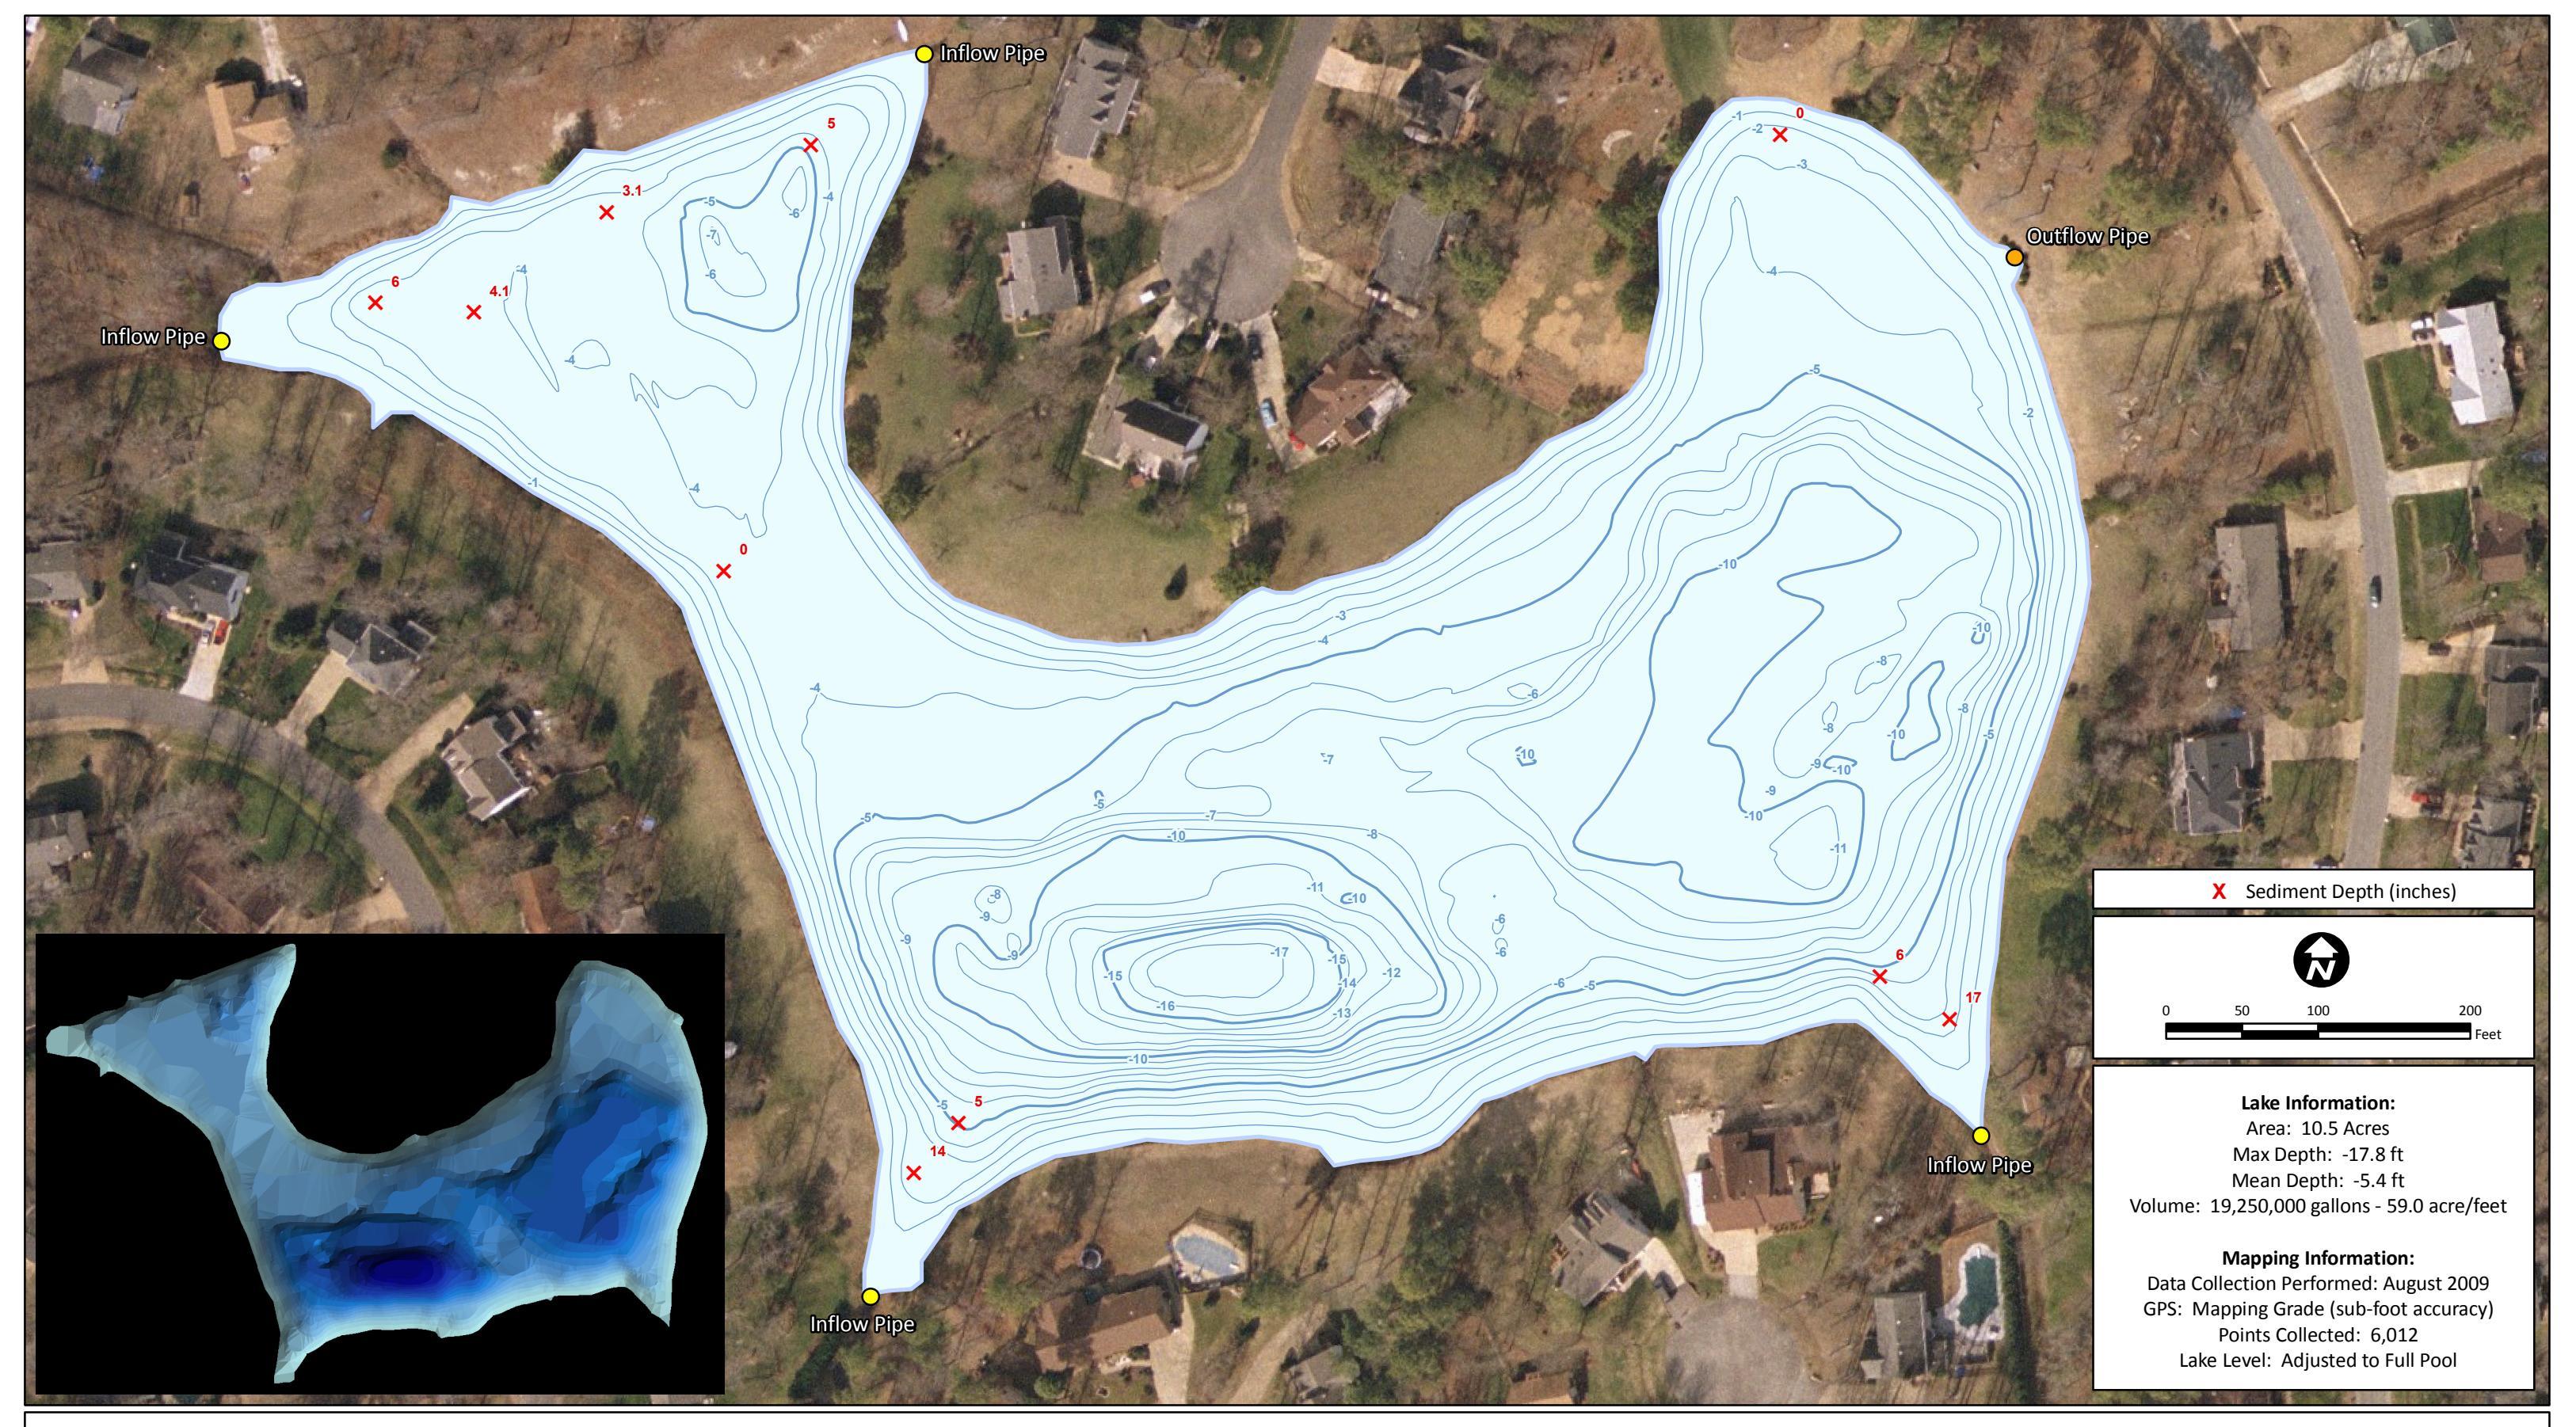
Woodlake Crossing - Sediment

A sediment analysis was performed to determine the makeup of the bottom substrate of the pond. Around the inflow structures there is an accumulation of sediment and organic sludge topped with a layer of leaf litter. The organic sludge is a result of years of plant matter entering the pond and left to be broken down by anoxic bacteria. At this time the accumulation of organic sludge is not an urgent threat to the health of the pond but should be monitored to prevent future problems. The sediment accumulating at the outfall of the inflow structures should be cleared out to ensure proper flow during rain events.
